## Central Coast Regional Water Quality Control Board

**BIG BASIN WATER COMPANY, INC., BIG BASIN WOODS SUBDIVISION WWTP,  
HWY 236 AND FALLEN LEAF DRIVE, BOULDER CREEK, SANTA CRUZ COUNTY –  
NOTICE OF VIOLATION FOR WASTEWATER TREATMENT SYSTEM  
OPERATIONS, WASTE DISCHARGE REQUIREMENTS ORDER NUMBER 97-26,  
WDID # 3 441001001**

**Attachment 2**  
**Big Basin Woods Subdivision WWTP Figures**

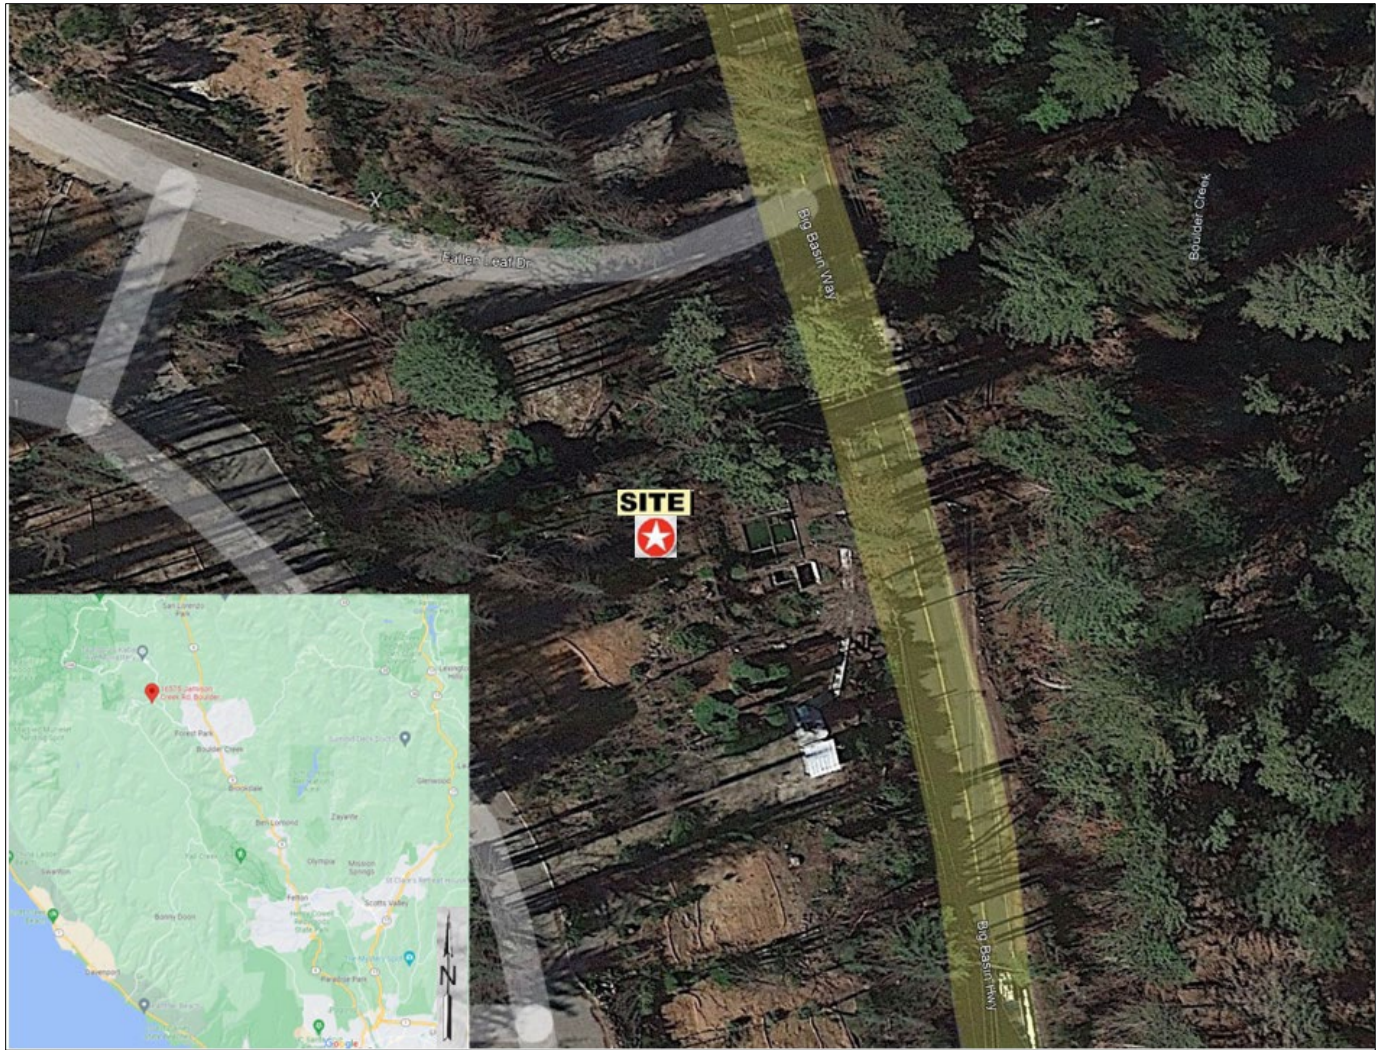
Figure 2: Big Basin WWTP site map

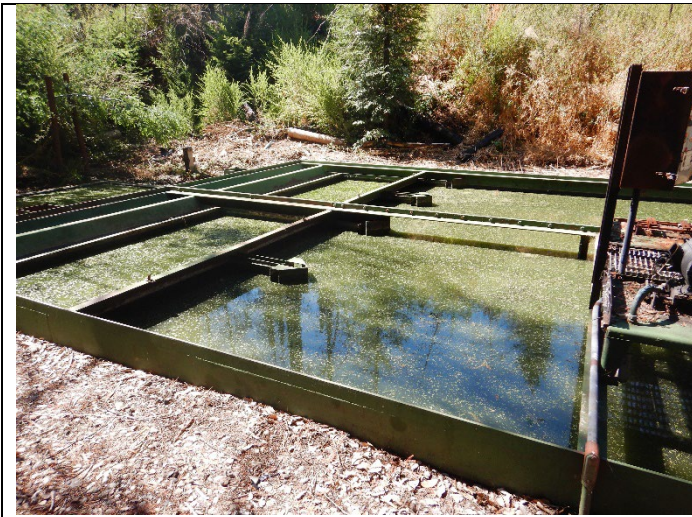
**Figure 3. Activated sludge basin acting as a holding basin for untreated domestic wastewater**

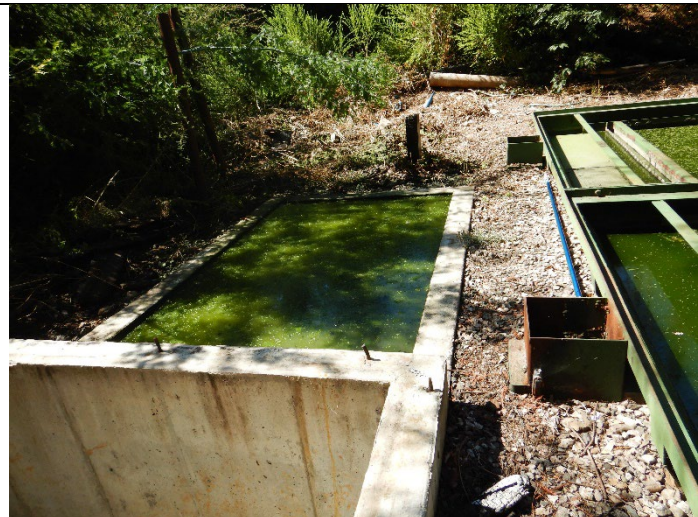
**Figure 4. Basin designed for treated effluent holding untreated wastewater over basin capacity**

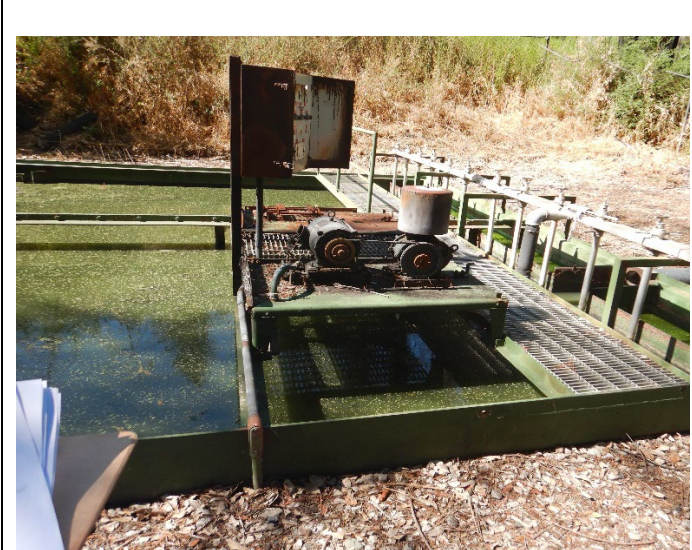
The WWTP blower motor control panel showed signs of fire damage as did the associated aeration blower. None of the equipment could be tested for function due to lack of electricity. Mr. Moore stated he would need to run new conduit and wires to connect the equipment to test once he receives power.

**Figure 5. Existing Aerator motor impacted by fire damage**

Mr. Moore discussed his difficulty getting the necessary permits to bring electricity to his plant and there was a lack of funds necessary to replace aeration blower, associated motor control panel, and the effluent pump. Mr. Moore stated that with his current service rates he is unable to obtain the appropriate funding necessary to complete the

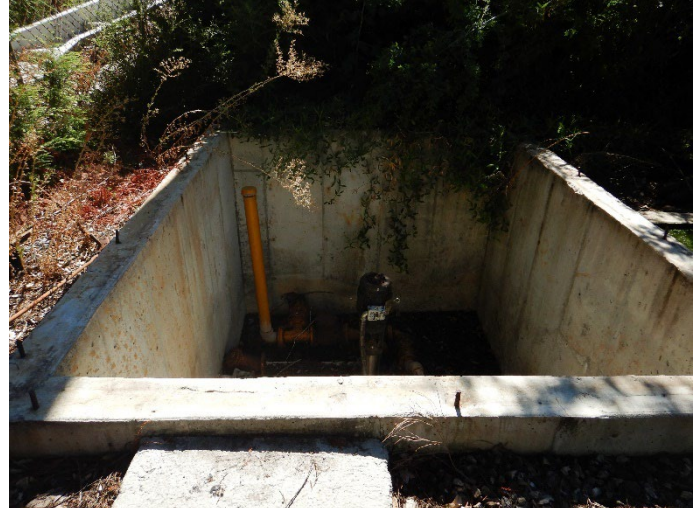
**Figure 6. Existing pump impacted by fire damage**

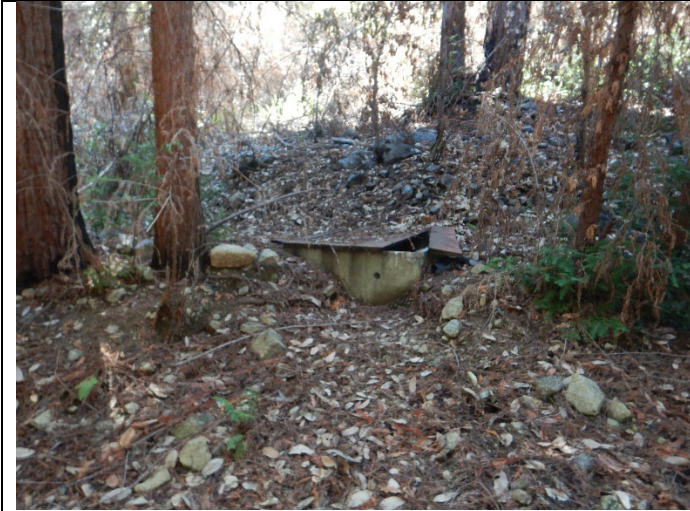
Central Coast Water Board staff followed Mr. Moore to the subsurface disposal area. Mr. Moore indicated that the existing leachfields were inactive and recent discharge of wastewater had not occurred. Central Coast Water Board staff observed no signs of recent discharge to the leachfields per observation of the leachfield dispersal boxes.

**Figure 7. Inactive Leachfield disposal area**

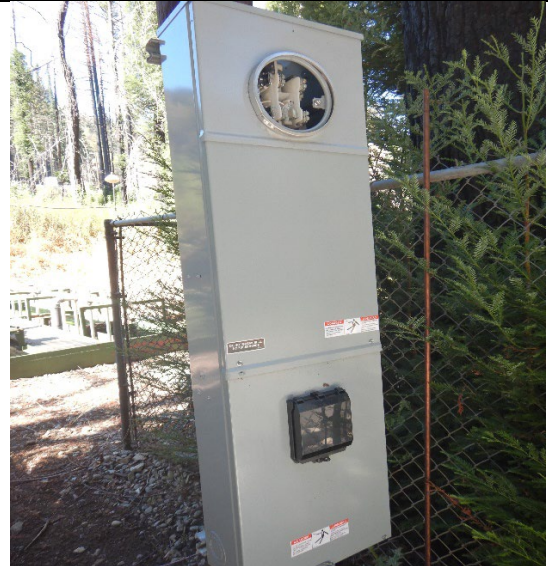
**Figure 8. New incomplete electrical box**

Mr. Moore stated that he'd continue to work on getting power at the WWTP and then determine what components of the WWTP are functioning or in need of repair/replacement.

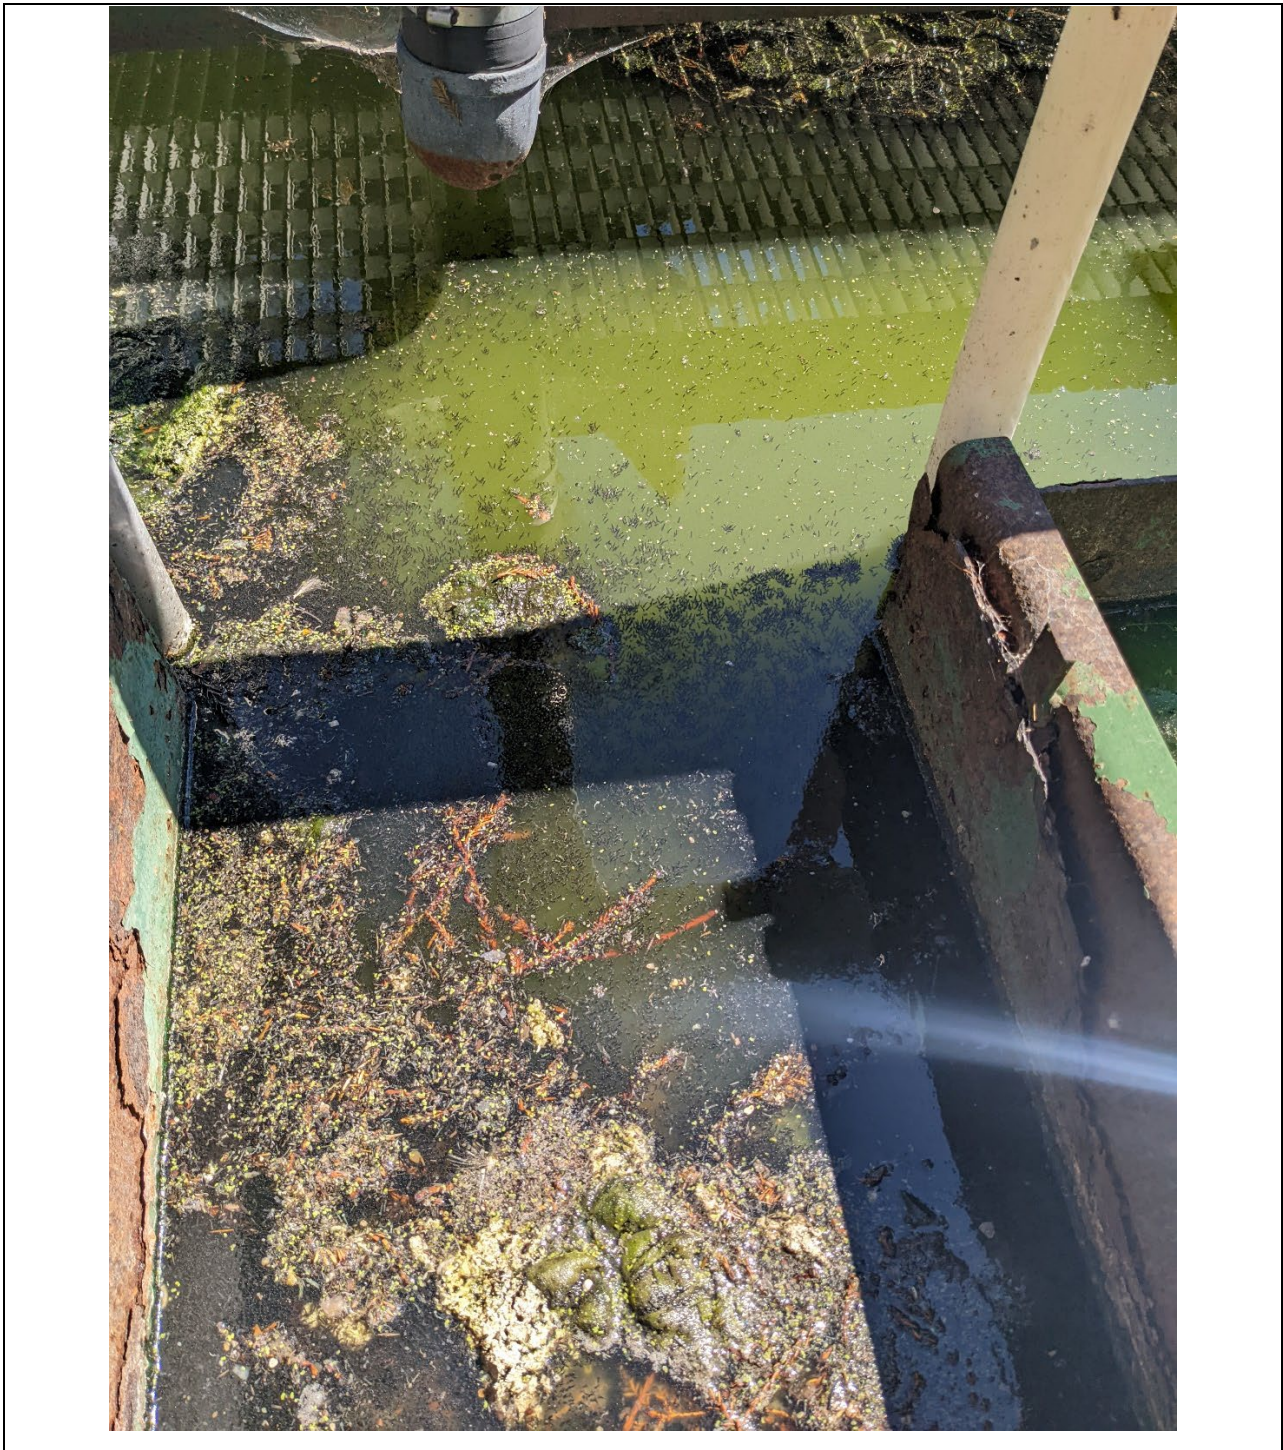
On August 29, 2022, the County of Santa Cruz contacted Central Coast Water Board staff regarding their public health concerns related to the significant mosquito breeding within the wastewater treatment basins at the WWTP. On August 30, 2022, Santa Cruz County mosquito and vector control staff confirmed dense breeding of mosquitos at the WWTP and applied a larvicide to the basins. Santa Cruz County mosquito and vector control staff have continued to treat the basins with larvicide on a regular basis (September 16, 2022, September 30, 2022, and October 27, 2022). See Attachment 3 for Santa Cruz County's inspection report and Attachment 2, Figures 1-3, and 7 for photos.

**Figure 1: Wastewater basin at full capacity with mosquito larvae buildup**  
**Photo taken by Sierra Ryan, Water Resources Manager, County of Santa Cruz County**  
**Environmental Health on August 26, 2022**

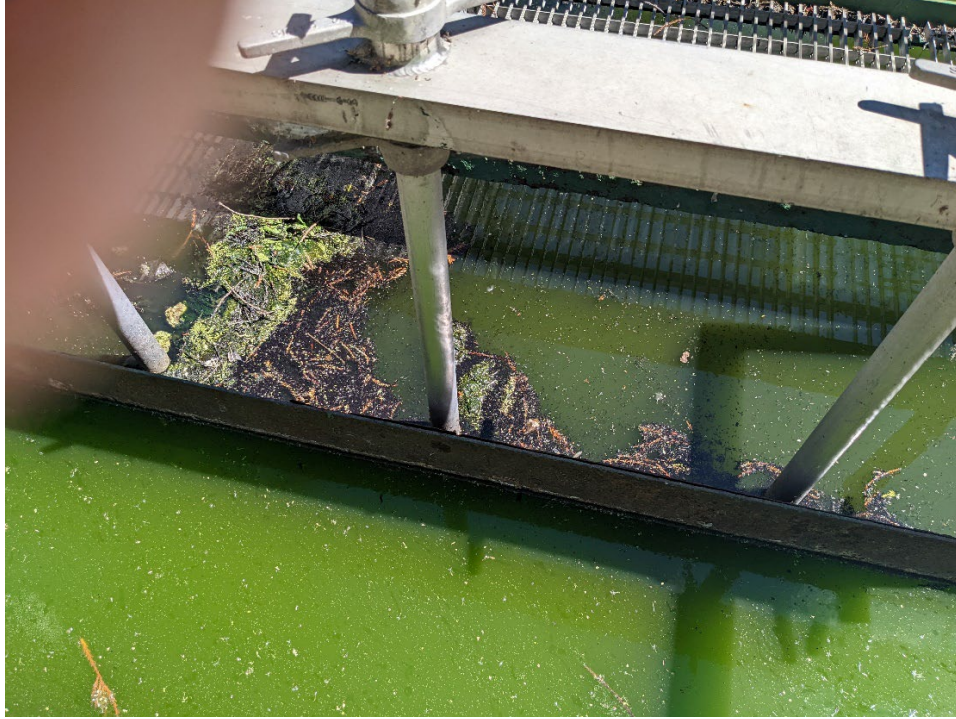
**Figure 2: Wastewater basin at full capacity before mosquito abatement**  
Photos taken by Sierra Ryan, Water Resources Manager, County of Santa Cruz County Environmental Health on August 26, 2022

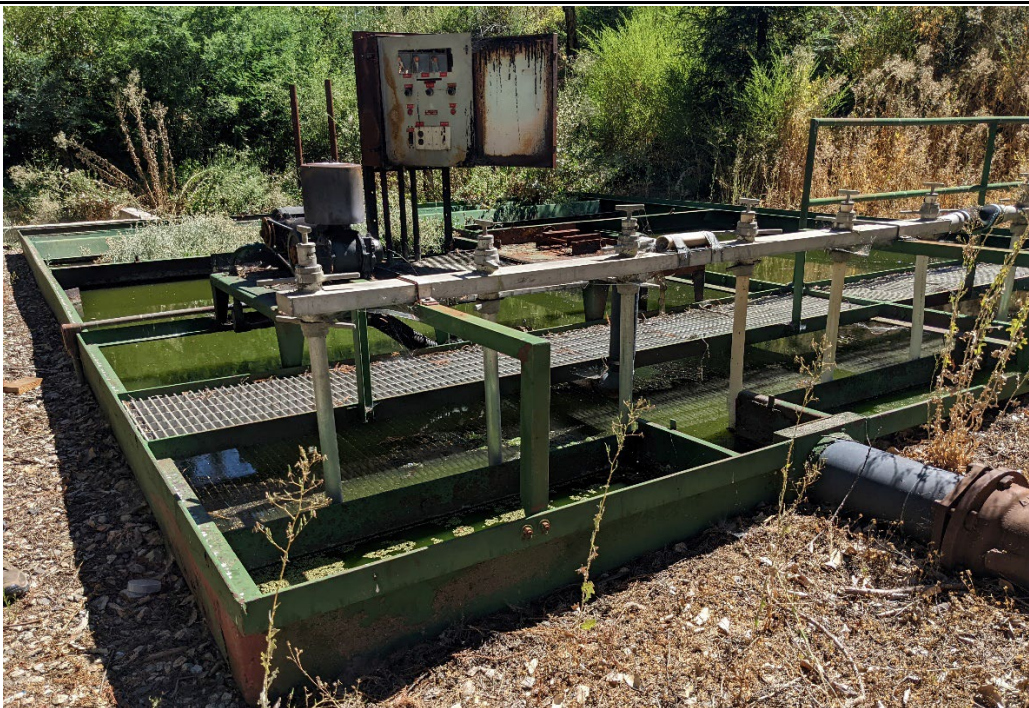
**Figure 3: Wastewater basin at full capacity**  
Photos taken by Sierra Ryan, Water Resources Manager, County of Santa Cruz County Environmental Health on August 26, 2022

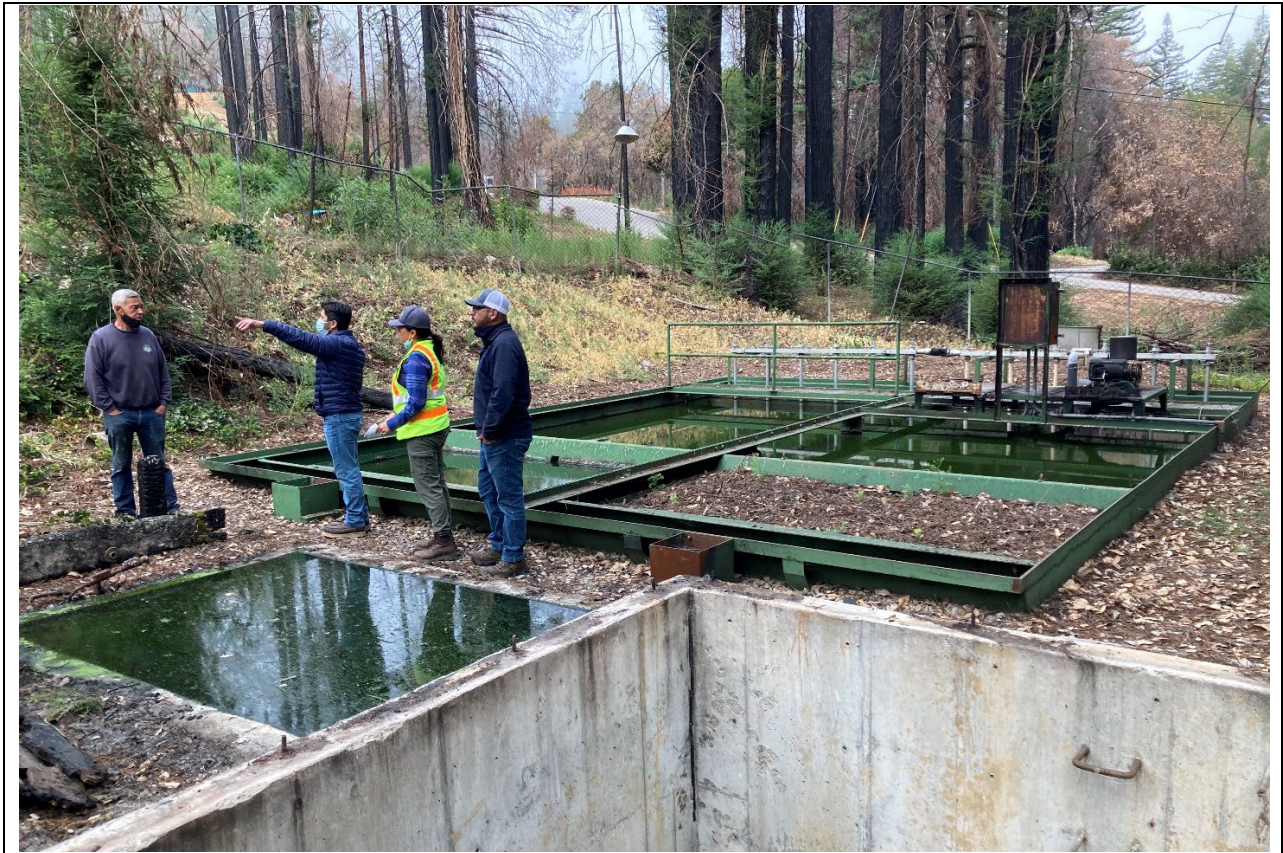
Big Basin Water Company violated Permit section A.1 by discharging untreated wastewater onto the ground adjacent to the basins. On September 9, 2021, Santa Cruz County staff observed evidence of untreated wastewater overflowing one of the basins (see Attachment 2, Figure 4). On August 30, 2022, and October 27, 2022, Santa Cruz County mosquito and vector control staff observed that one of the basins holding untreated wastewater was overflowing (see Attachment 2, Figure 7). Photos from the September 22, 2022 Central Coast Water Board inspection show evidence of basin overflow (see Attachment 1, Figure 4). On November 2, 2022, California Department of Fish and Wildlife staff observed untreated wastewater overflowing one of the basins (see Attachment 2, Figure 6).

**Figure 4: Wastewater basin overflowing.**  
**Photos taken by Kent Edler, Assistant Director- Special Services, Santa Cruz County on September 9, 2021**

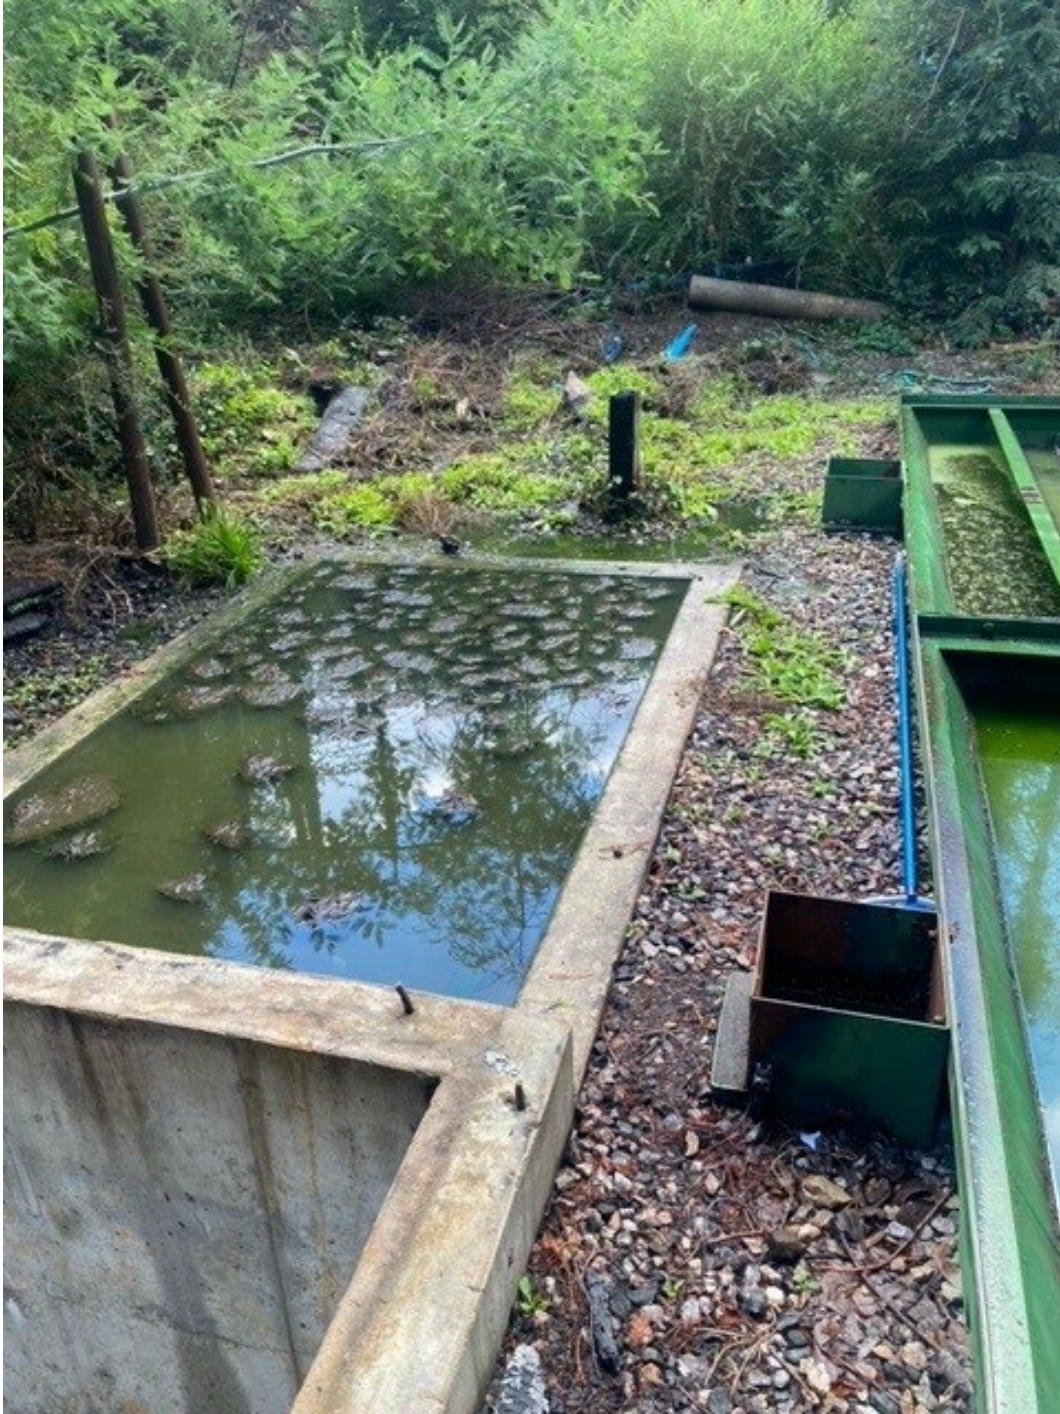
On November 2, 2022, a California Department of Fish and Wildlife warden inspected the WWTP. The warden observed the basin on the south side of the WWTP overflowing (see Attachment 2, Figure 6).

**Figure 6: Untreated wastewater overflowing basin**  
Photo taken by Kristy Emershy, California Department of Fish and Wildlife, Santa Cruz Harbor District on November 2, 2022

Big Basin Water Company must address the alleged violations described above and perform immediate and regular pumping. Big Basin Water Company must **submit by November 28, 2022**, a written response describing the actions taken or planned to address the above alleged violations and prevent future violations. For violations that Big Basin Water Company has not addressed immediately, the response must include a time schedule for corrective actions to bring the WWTP back into compliance with the requirements of the Permit.

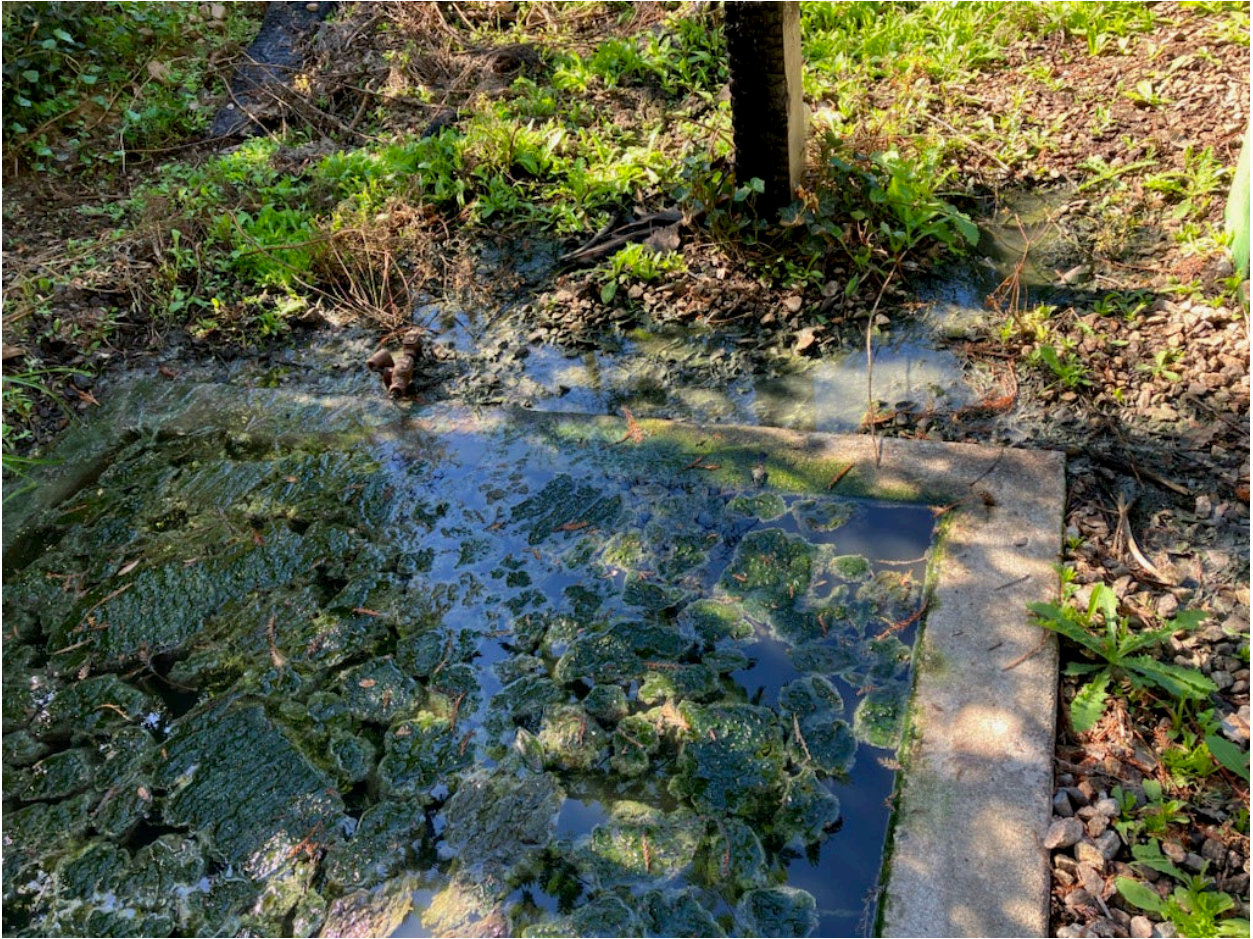
The WWTP has been inoperable and is currently just collecting untreated wastewater in open basins. On August 30, 2022, Santa Cruz County mosquito and vector control staff visited the site and reported big stagnant basins of wastewater that had become concentrated mosquito larvae breeding habitat. Santa Cruz County staff reported, *“confirmed dense breeding of Culex species of mosquitoes which can transmit West Nile virus. The large quantities of mosquitoes produced by this wastewater treatment facility constituted a public health concern to the surrounding residents.”* See Attachment 3 for Santa Cruz County’s inspection report and Attachment 2 Figures 1-3 for photos taken by mosquito and vector control staff. Big Basin Water Company has collected untreated wastewater over an extended period of time and there is no evidence of wastewater removal or treatment.

**Figure 7: Untreated wastewater overflowing basin**  
**Photo provided by Nader Sidhom, Vector Control Specialist, Santa Cruz County Mosquito and Vector Control and taken on October 27, 2022**

On August 30, 2022, Mosquito & Vector Control met with the property owner Jim Moore to discuss the mosquito breeding issue. The owners of this property should take all necessary actions to abate these conditions as required by the California Health and Safety Code (Division 3, Chapter 1, Section 2000, *et. seq.*) and/or Chapter 1.14 of the Santa Cruz County Code. It is recommended that the standing water be pumped and removed regularly. If the water cannot be removed, it is recommended that the Big Basin Water Company continuously circulate or aerate the water to prevent mosquito breeding within all chambers of the facility. Mosquito & Vector Control will continue to monitor the site throughout the transition to County Sewer.
